CT TECHNOLOGY
TRAFFIC CONTROL SYSTEMS AND SOLUTIONS

CASE STUDY

BRISTOL CITY COUNCIL

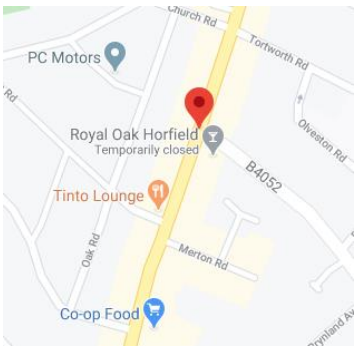
A few months ago, one of the SCOOT inductive loop detectors failed at the Gloucester Road and Ashley Down Road junction.

The detector was on the outbound approach, adjacent to a side road, as shown to the right. The positioning of the detector was optimal for SCOOT operation and could not be easily repositioned, but the location meant that re-cutting the loop detector would involve expensive traffic management, including three-way temporary traffic signals.

This issue made a traditional detector repair too expensive to be viable, given Bristol City Council's (BCC) budgetary constraints. BCC explored the alternative options available. It was decided to trial the Iteris VersiCam video detection system, which could be installed onto a nearby traffic signal head and powered using six (6) spare cores available within the head. The detector would then be used as a Filter detector for the outbound movement.

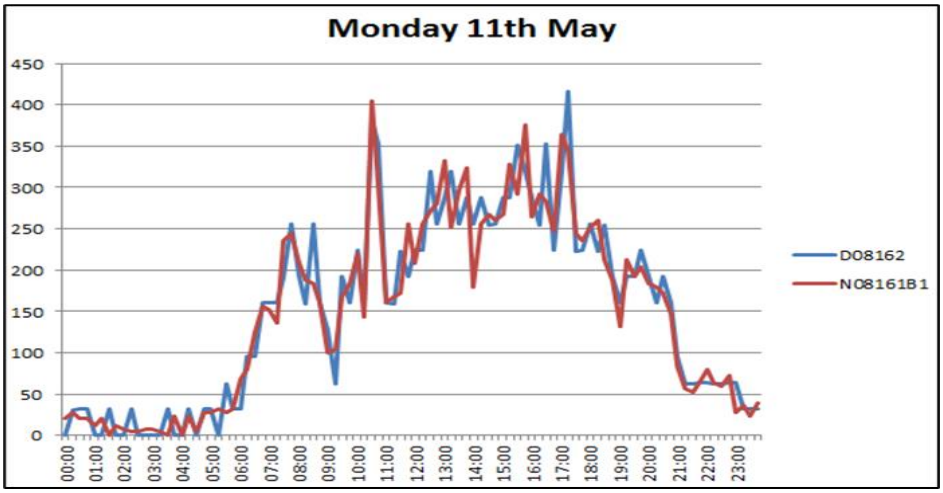
The graph to the right shows a comparison of the SCOOT detector data and the count site data generated.

The graph shows that the SCOOT detector is providing an accurate count, as the SCOOT model is taking the 1/4 second detector presence values and converting them into LPU's. To check the performance of the above ground detector, we have graphed the count data against the LPU value, which has been converted back into vehicles / hr, by dividing the value by 17. The results demonstrate that the detection zone and therefore the input into UTC is correct as the SCOOT models' LPU conversion matches closely with the count values from the sensor.

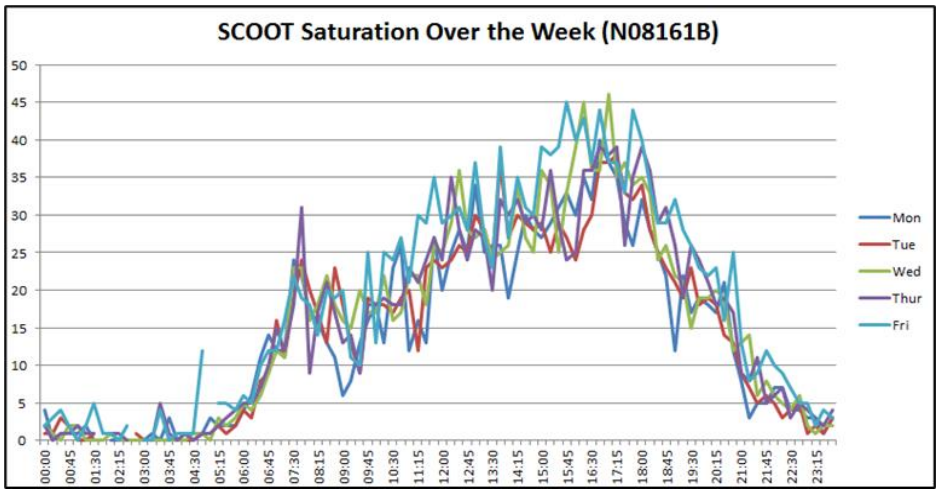
The performance of the SCOOT link was then checked, and it was apparent from the data that the link was modelling as expected. The graph below shows the SCOOT Saturation data derived from the detector. It is consistent throughout the week, which supports that the sensor provides a consistent and reliable performance.

The data shows similar consistency / reliability at night as in the day. This is also reflected in the slightly higher saturation on the Friday evening, which accurately reflects the actual traffic conditions on Friday evenings.

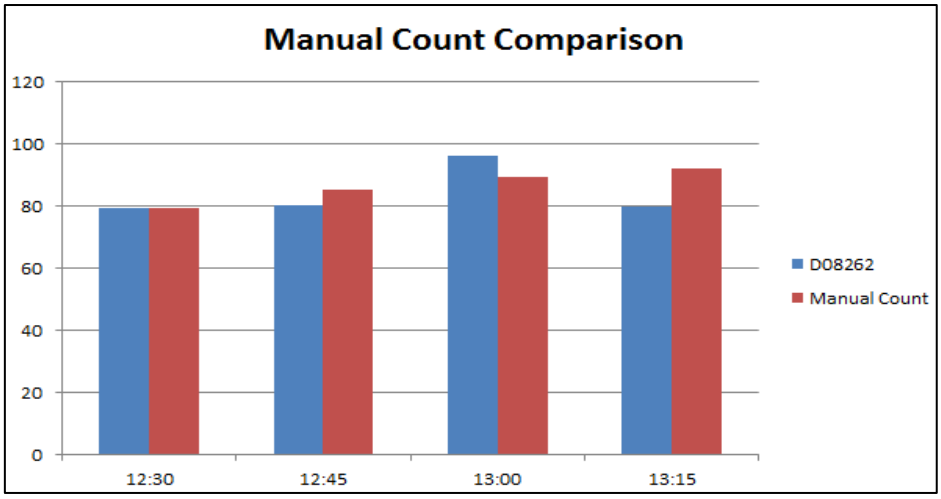
A manual traffic count was also compared against the count site using the VersiCam as an unclassified count site. The totals are shown below, and graph of the manual count is shown on the right.

This shows that the manual counts, and the SCOOT detector's automated counts were very close. The differences can be explained as follows:

• There were a lot of vehicles that had poor lane discipline and were using lane 2, rather than lane 1 . It is possible that not all of these vehicles were detected, as the sensor was for lane 1 (ahead) traffic only.

• The count site replies to UTC in blocks of 8. So a reply would only be sent back to UTC after 8 vehicles have been counted. This may explain the discrepancy between the 13:00-13:15 and 13:15-13:30 time periods.
